Pre Purchase Building Report

Example Street Somewhere .

ppexample0117

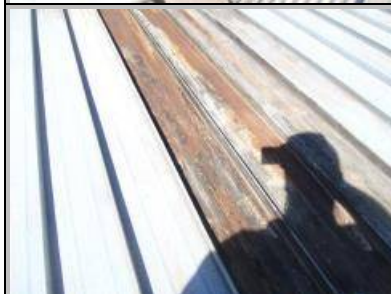
The overall condition of the skillion roof coverings is fair.

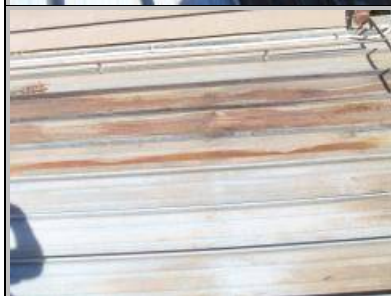
Water is ponding on the flat roof section. This situation must be rectified to prevent water entry.

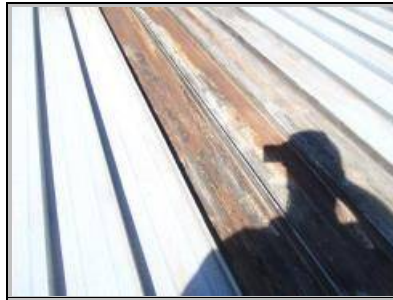
The metal roofing is rusting and requires repairs and rust inhibiting treatment to ensure the roof remains watertight and to limit further deterioration until such time that replacement of the roof sheets is required.

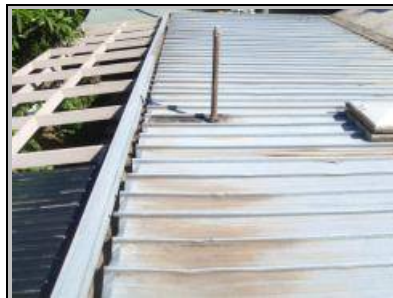
The gutters and downpipes are in good condition. Leaves and debris are present in gutters. These should be cleared to ensure that stormwater is adequately removed from the roof. Note that due to inability to inspect all gutter surfaces due to debris, defects may be present that do not present themselves until gutters are cleaned.

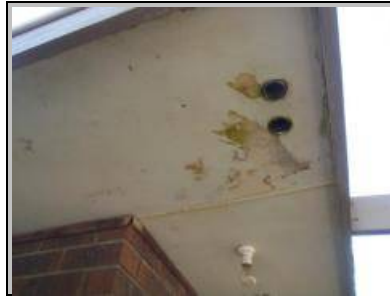
The paint work to the eaves is deteriorating in some areas and maintenance is required.

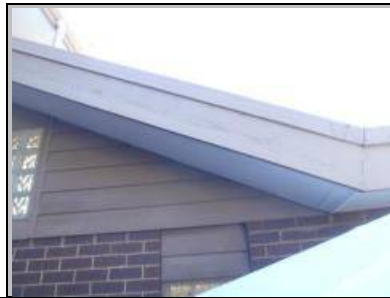
Fascia boards are constructed of timber. The paint work is deteriorating and maintenance is required.

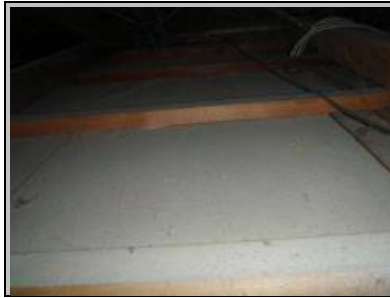
There is no insulation provided to the pitched roof ceiling cavity.

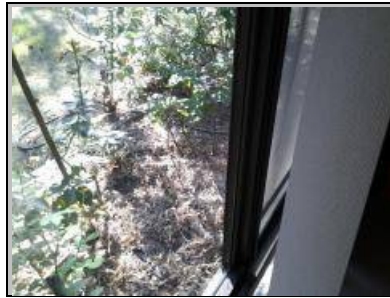
The window catch is missing and requires repair / replacement to restore correct function and security.

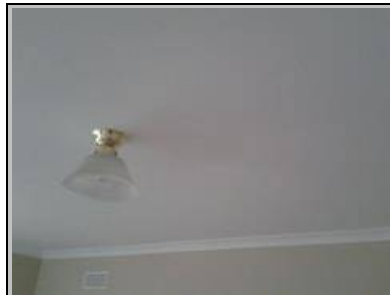
The condition of the ceilings is generally good. Minor settlement cracks were noted, these are typical of this type of material. Periodic maintenance may be required.

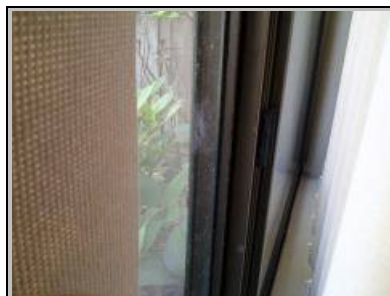
The window catch is broken/ damaged and requires repair / replacement to restore correct function and security.

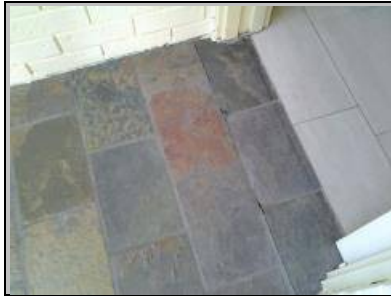
Cracking is evident to some floor tiles. Cracked or damaged floor tiles should be replaced.

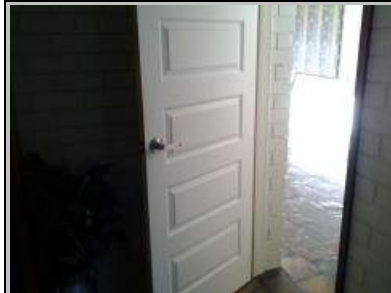
The door binds and minor adjustments are required to ensure correct operation.

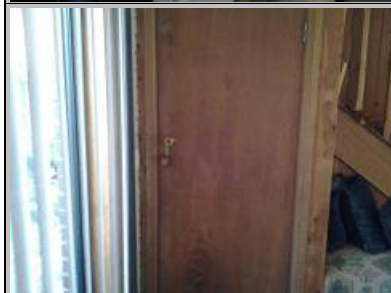
The door binds and minor adjustments are required to ensure correct operation.

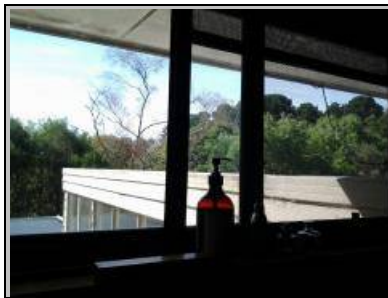
The condition of the windows is generally good. The window catch is missing and requires repair / replacement to restore correct function and security.

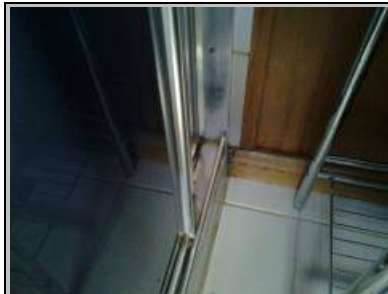
The condition of the woodwork is generally good. Wet rot decay damage was noted to skirting board. Any damage will require maintenance, repair or replacement.

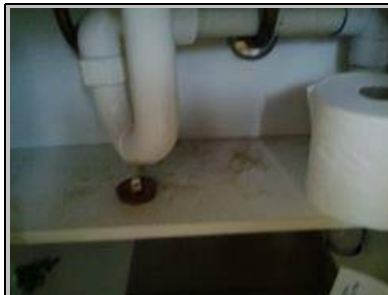
Water staining noted to vanity cabinet. Repairs or maintenance will be required.

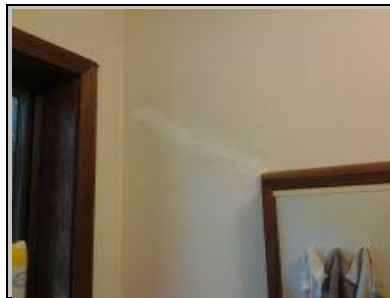
Moderate cracking is evident to wall linings. Periodic maintenance may be required.
-----------------------------------------------------------------------------------	-------------------------------------------------------------------------------------

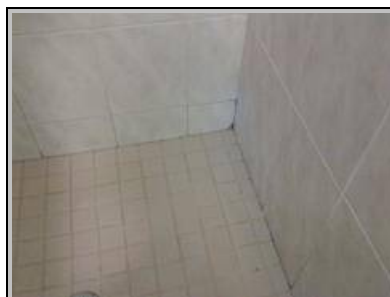
The condition of the splashback tiles is generally good. Some cracked tiles were noted in this area. Rectification may be necessary, contact a floor and wall tiler for rectification.
-------------------------------------------------------------------------------------	----------------------------------------------------------------------------------------------------------------------------------------------------------------------------------------

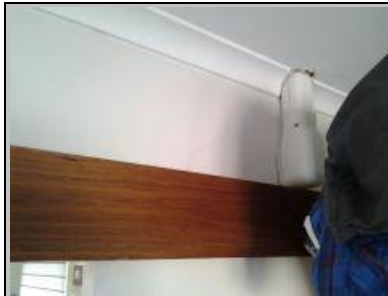
The condition of the walls is generally good. Moderate cracking is evident to wall linings. Periodic maintenance may be required.

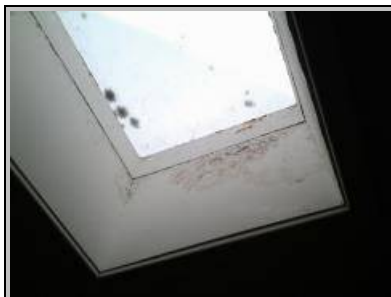
Rusty and water damaged light well needs repair to improve appearance.

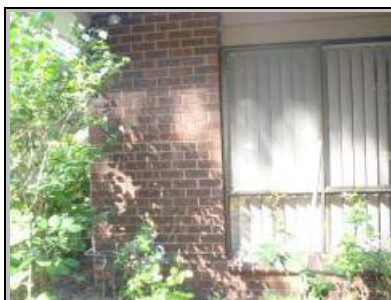
Cracks are evident. Visible cracking has been categorized as a structural defect. Cracking of a building element is a structural defect where in the opinion of the inspector the structural performance of the building element is impaired, or where the cracking is the result of the structural behavior of the building. The expected consequence of this cracking is unknown until further information is obtained.

This must be referred to a Structural Engineer to investigate.

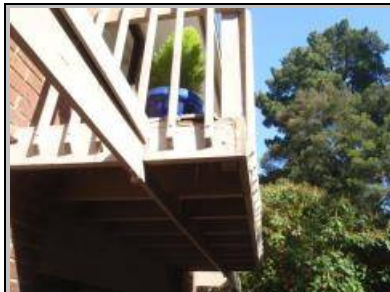
Moderate to severe wood decay is present to the structure. Some repairs or maintenance will be required.

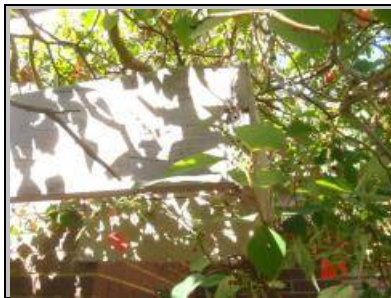
Moderate wood decay is present to the structure. Some repairs or maintenance will be required.

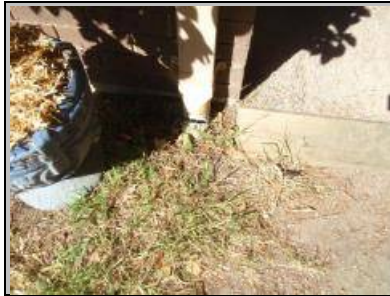
Front right downpipe socket is broken and needs repair to control the stormwater.

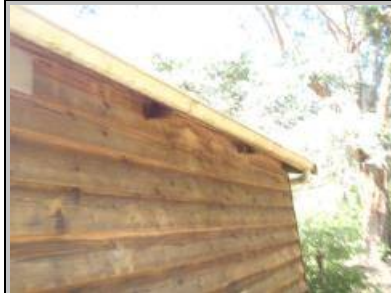
The overall condition of the roof coverings is good. The gutter need to be realigned to control the flow f stormwater.

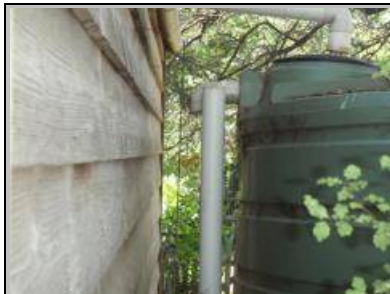
Water tank over flow pipe needs to be connected to the over flow pipe.
